Manhole Inspection Summary

Manhole # S19I1_022MH

Insp Date: **4/22/08 3:02 PM**

Location Address: **2516 southdene av**

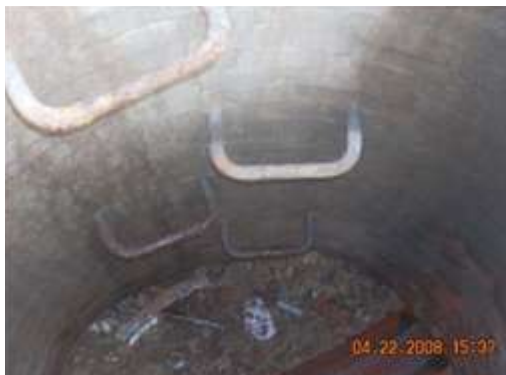
Defect 3

Steps Count: **4** Missing: **0** ☒ **Corroded**

corroded steps

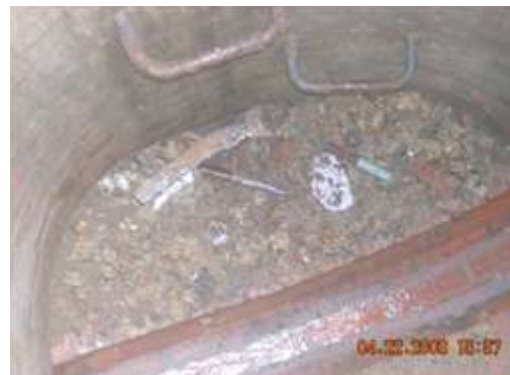
Defect 2

Condition: ☐ Sound ☐ Cracked ☐ Root Intrusion ☐ Deteriorated ☐ Leaks ☒ **Debris**

debris on bench

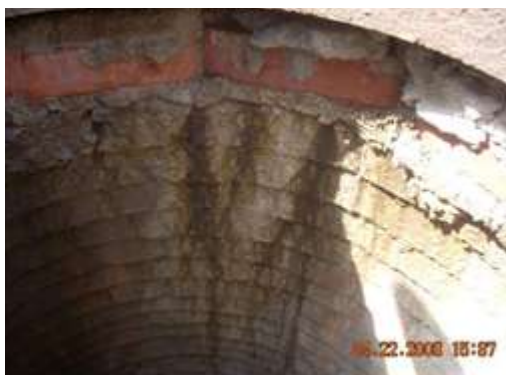
Defect 1

Condition: ☒ Sound ☐ Cracked ☐ Root Intrusion ☐ Loose Brick ☒ **Deteriorated**

Infiltration: ☐ None ☒ **Joint** ☐ Cracks ☐ Mortar ☐ Roots ☐ Wall

infiltration @ corbel/chimney joint,
deteriorated

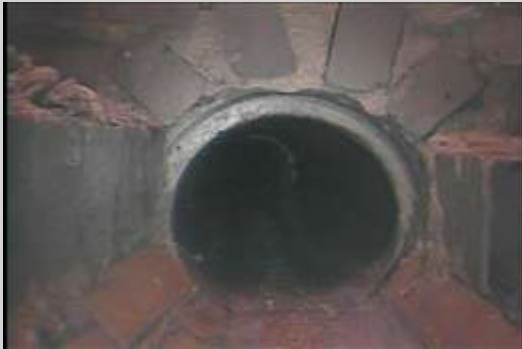
12 O'Clock Outflow

Pipe Height: **8.4** (in.) Rod and Bar (Angled)
Pipe Material: **Clay** ☐ Pipe Lined
Invert Depth: **8.90** (ft.) Flow Characteristics: **Fast**
Deposits: ☒ None ☐ Mud ☐ Sludge ☐ Debris ☐ Grease
Silt Depth: **0** (in.) Deposits Extent:
Infiltration: **None** Pipe Seal Cond: **Sound**

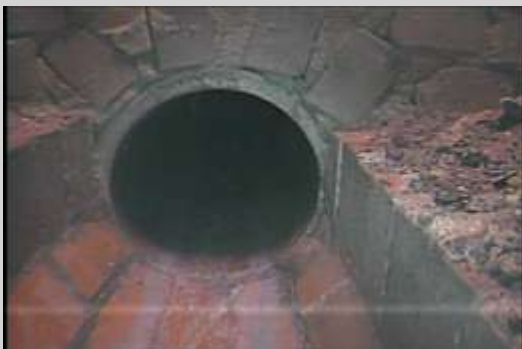
7 O'Clock Inflow

Pipe Height: **8.4** (in.) Rod and Bar (Angled)
Pipe Material: **Clay** ☐ Pipe Lined
Invert Depth: **8.55** (ft.) Flow Characteristics: **Fast**
Deposits: ☒ None ☐ Mud ☐ Sludge ☐ Debris ☐ Grease
Silt Depth: **0** (in.) Deposits Extent:
Infiltration: **None** Pipe Seal Cond: **Sound**
